# Technical Bulletin

Model  
911C2/C4

**Subject:** Cruise Control Diagnosis

Number  
9004

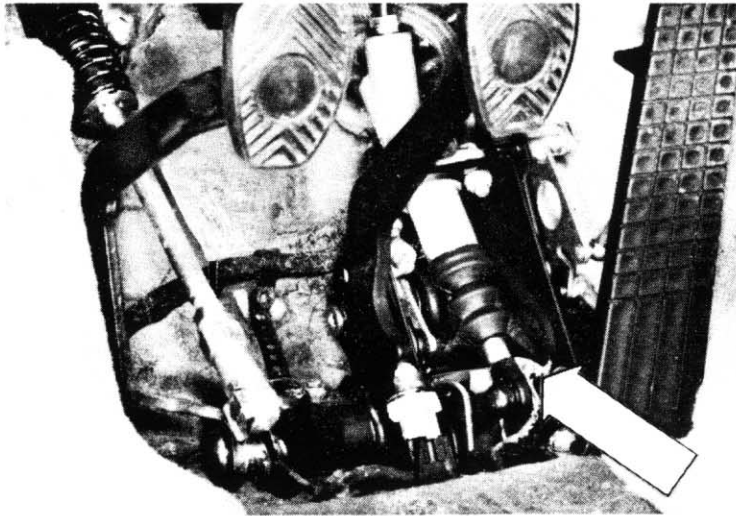
**Concern:** A loose or misadjusted clutch pedal switch may cause the cruise control to become inoperative.

**Repair Information:** The clutch pedal microswitch circuit **should open** with clutch pedal depressed  $15 \pm 2\text{mm}$  (audible click). If necessary, loosen switch mounting screws and adjust switch. Make sure mounting screws are tight after adjusting or when checking switch.
