Technical Bulletin

Subject: Discharged Battery/Alarm System Malfunction

9308

Models Affected: All 4, 6 and 8 cylinder cars from Model Year 1989

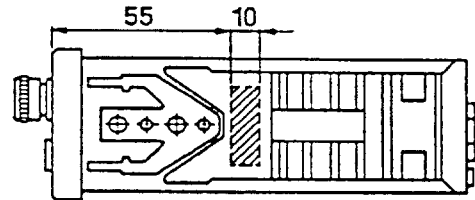
Concern: Incorrect radio installation can cause a discharged battery and alarm system malfunction through the alarm system contact on the radio mounting frame.

With all other radio types, the alarm contact is part of the radio mounting frame and works in conjunction with an insulating strip adhered to the right side of the radio housing. (See illustration.)

1. When the radio is fully installed, the alarm contact on the radio frame must bear against the insulating strip on the right side of the radio. If the insulating strip is not installed, the battery will become discharged and the alarm system will malfunction.
2. When service installing a radio or replacing the original type of radio with another type (excluding CD-2 and CR-1), the radio mounting frame with integrated alarm contact can be installed. The alarm contact connecting cable is already installed in the area of the radio opening in the dash.
