Technical Bulletin

Subject:
**Knocking Noise
While Turning the Steering Wheel**

Number
9404

Models Affected: **911 Carrera 2/4/Turbo
Model Year 1992 and 1993**

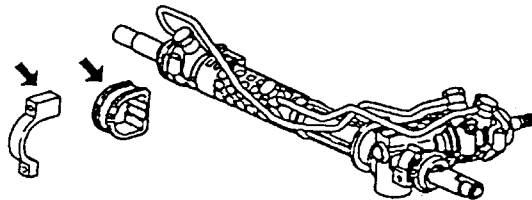
Concern: When turning the steering wheel with the vehicle standing or while parking, knocking noises could occur. The reason for this noise may be very small movements in the holding clamp of the rack and pinion steering. This, however, has no negative influence toward the function or safety of the steering.

Repair Information: If a customer complains of knocking noises in the steering, the modified holding clamp can be installed. To do so, loosen and replace each clamp separately. If necessary, clip out the ATF lines.

When installing the modified clamp, the rubber mount must be replaced. Also, clean the mounting bolt holes free from glue deposits, and torque the bolts to 45 Nm (32.5 ft.lbs.).

After installation, check the steering wheel centering and, if necessary, correct position.
