Technical Bulletin

Model
911C2/4

Subject: Rear Side Panel Support Modified

Number
9003

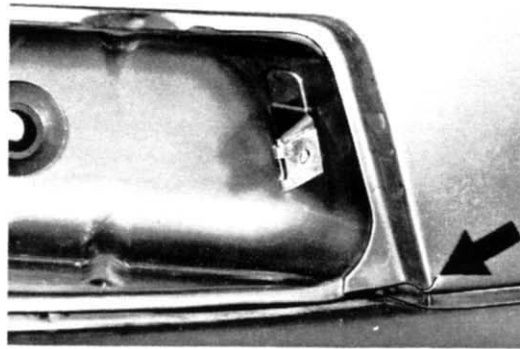
Figure 1

Concern: Vibration of the rear side panels (fenders) can cause cracks in the area of the tail lights (Figure 1).

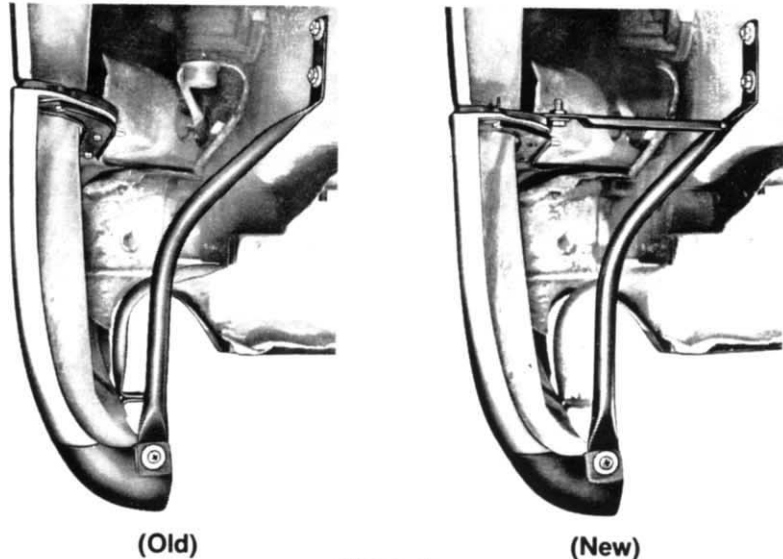
Figure 2

New side cover panel brackets with additional support installed (Figure 2).
