Technical Bulletin

Model
911C2/C4

Subject: Spoiler Drive Cable Cap

Number
9103

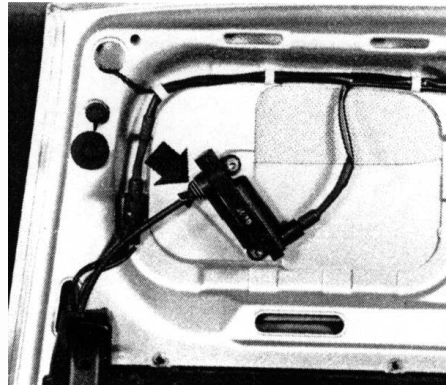
Figure 1

Concern: Water enters rear spoiler motor through spoiler drive cable cap (Figure 1).

The cap should be replaced on all 89 (K) and 90 (L) model year vehicles up to the above VIN when the vehicle is in the workshop for normal service or other repairs.
