# Technical Bulletin

**Model**  
911 C2/C4  
911 Turbo

**Subject:** Removal of Fuses  
During Transportation/Storage

**Number**  
9306

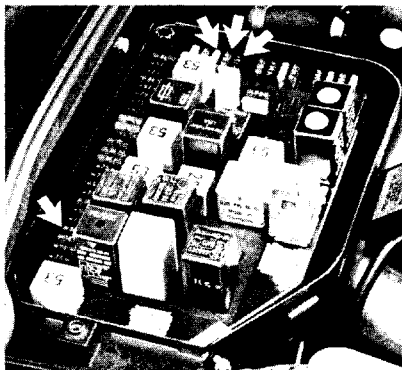
**Figure 1**

**Coupe**  
Pos. A = Off

**Targa & Cabriolet**  
Pos. B = Off

**Repair Information:** When receiving a vehicle for dealer inventory, the vehicle's CEB should be checked to assure the appropriate fuses have been removed and interior lighting switches have been turned to the off position. The fuses are to be placed in a plastic bag in the vehicle's glove compartment (see Figure 1).
