Technical Bulletin

Model
1990-92
911 C2 Tiptronic

Subject: Engine Speed Sender Clearance
(Tiptronic Transmission)

Number
9301

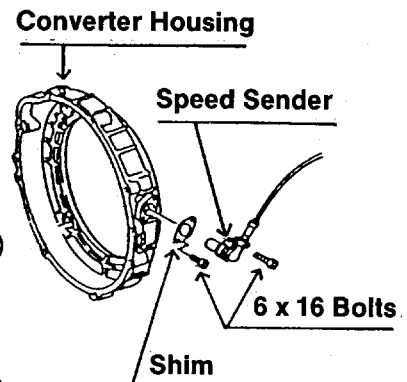
Concern: The air gap between the engine speed sender and the carrier plate sensing ring is adjustable. If the adjustment is not made correctly, damage to the sender and /or DME electronic control unit can occur.

Some vehicles produced between 1990 and 1992 have only one bolt holding the sender to the converter housing. If this is noticed during repair procedures or vehicle inspection, the vehicle should have two new bolts (Part Number 999 218 005 02) installed.

General Information: If the shims for the speed sender have been lost or the speed sender has been changed during repair procedures, the air gap between the speed sender and the carrier plate sensing ring should be set and two new micro encapsulated bolts (Part Number 999 218 005 02) should be installed.

During adjustment procedures, any combination of shims may be used to obtain the correct air gap ($1\text{mm} \pm .2\text{mm}$) between the sensing ring and speed sender.
